**Serious Injury Collision, St Vincents Road, Banyo
14 September 2012**

Final report, rail incident investigation TMR 4617

Major rail incident investigation

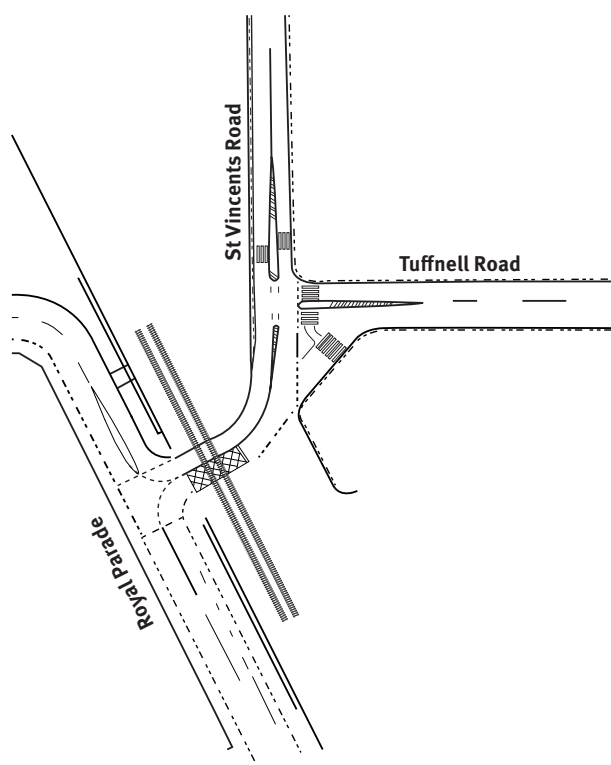
Figure 2: St Vincents Road level crossing layout

The level crossing is a straight section of roadway. Directly after the level crossing, St Vincents Road turns approximately 90 degrees to the left, which requires long vehicles to utilise a portion of the eastbound lane on the level crossing to negotiate the tight corner. The road layout is depicted in Figure 2.

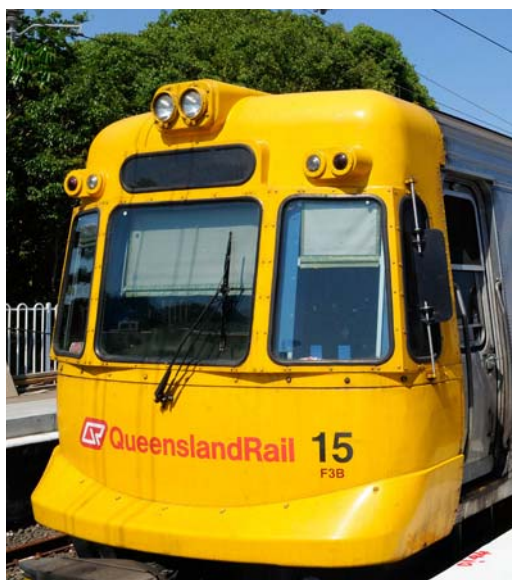
Figure 3: Electric Multiple Unit

The northbound train was a six car Electric Multiple Unit (EMU) and is depicted in Figure 3. The train was made up of two three car units coupled together. The northbound train had a length of 144.8m and a mass of 235.6 tonnes. The lead unit was fitted with a forward facing Closed Circuit Television (CCTV) camera. The trailing unit was fitted with an event recorder. At the time of the collision, the train was carrying about 20 passengers.

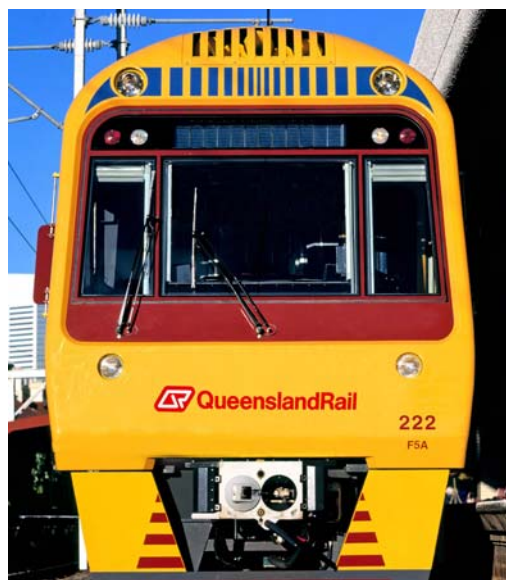
Figure 4: Suburban Multiple Unit

The southbound train was a six car Suburban Multiple Unit 220(SMU220) Series and is depicted in Figure 4. The train was made up of two three car units coupled together. The southbound train had a length of 144.8m and a mass of 244.2 tonnes. The lead unit was fitted with a forward facing CCTV camera and a data logger event recorder. On arrival at Banyo station, the train was carrying about 300 passengers.

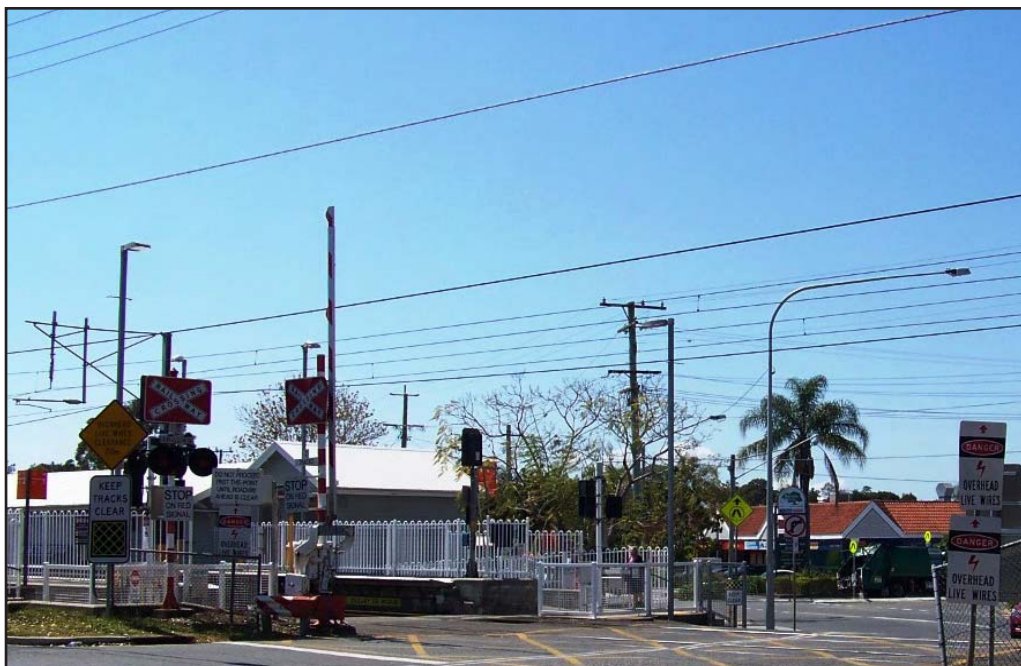
Figure 11: St Vincents Road level crossing

All of the recommended upgrades were completed in mid 2003 (refer to Figure 11). On 12 September 2012, the RTO assessed the St Vincents Road pedestrian level crossing as part of scheduled inspections. During this assessment, the RTO did not observe any issues relating to the road level crossing protection.

- installation of advance warning signs for road traffic
- cross hatching to be painted on the roadway
- the pavement markings on pedestrian pathway to be repainted
- installation of LED lights.
